Investigation Into the Effects of Microsecond Power Line Transients on Line-Connected Capacitors

K. Javor
EMC Compliance, Huntsville, AL

Final Report: Capacitor Transient Potential Tests

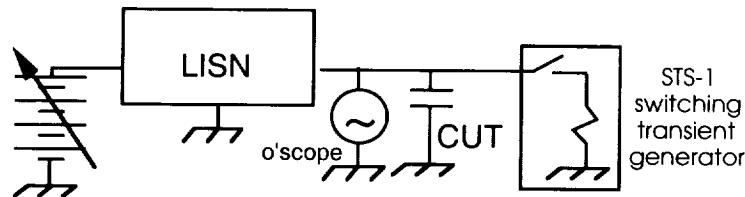
Figure 1: Schematic of switching transient test

Capacitor value is measured prior to test start, and again at end of spike application. The test is diagrammed in Figure 1. In Figure 1, CUT refers to capacitor-under-test.

The oscilloscope measures potential from line-to-ground at the LISN output. The nominal spike potential is measured without the capacitor in place, using a 1 or 10 M Ω oscilloscope probe. The spike is measured again with the capacitor in place. Spikes are imposed at a rate of at least 1 pps. Pictures of test set ups and capacitors are shown in Appendix A.

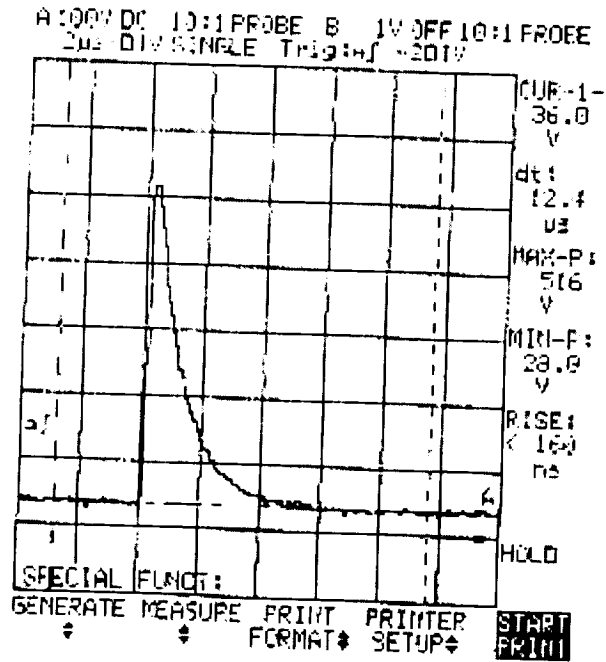
Data 1-1: 500 V spike injected on 28 Vdc

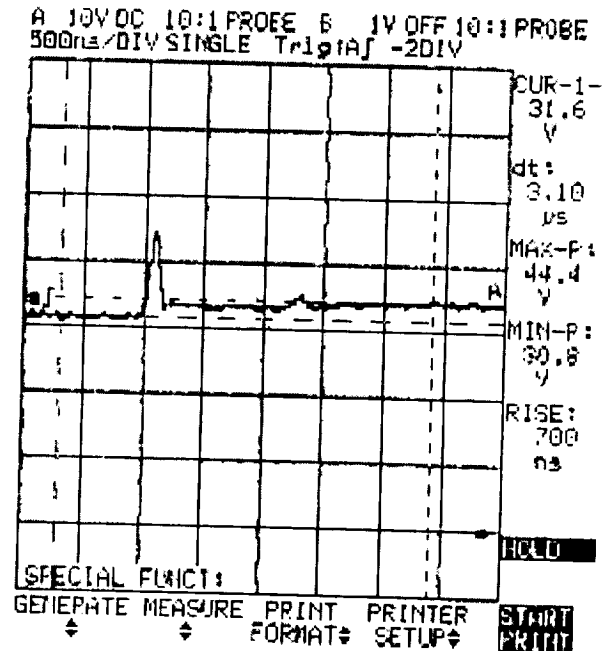
Data 1-2: Spike of Data 1-1 on capacitor A

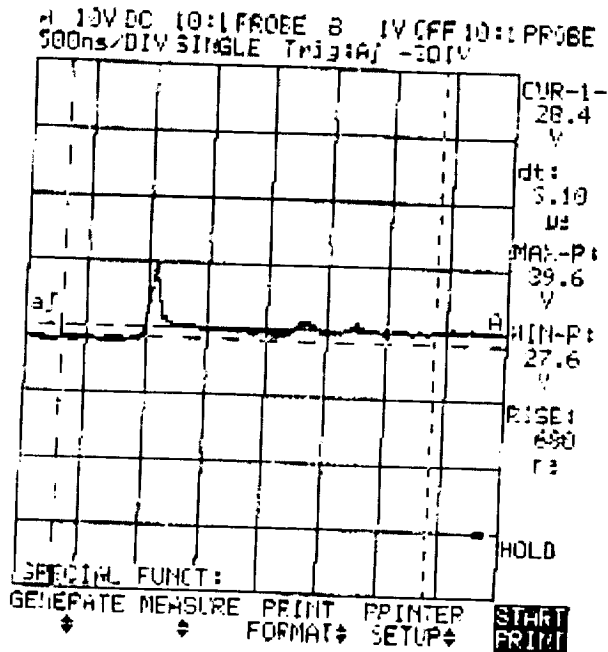
Data 1-3: Spike of Data 1-1 on capacitor E

In order to show just how benign the switching transient is, the same 500 Volt spike as of Data 1-1 was generated across a 300 μF tantalum electrolytic rated at 30 Vdc (Cap E), while it was biased at 28 Vdc. The resulting spike is presented in Data 1-3. It is almost identical to the spike of Data 1-2, except here the peak spike amplitude (spike plus nominal dc potential) exceeds the capacitor dc rating. Nevertheless, a three hour exposure at one pulse per second resulted in no observable change in capacitance, and no observed heating.

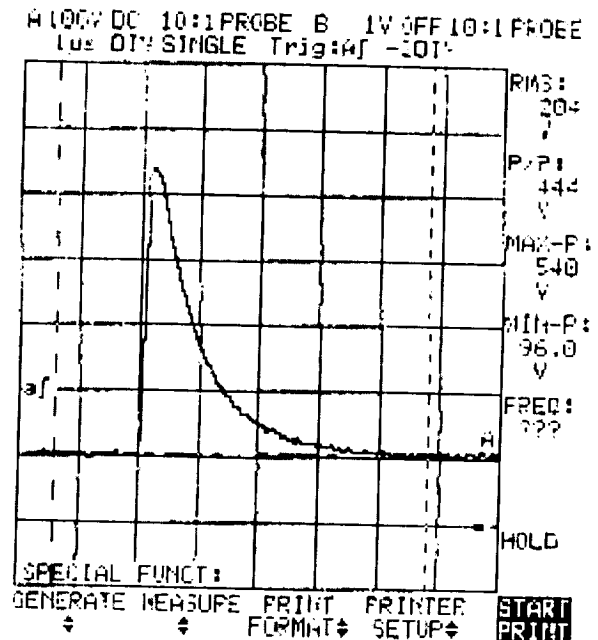
Data 1-4: 500 Volt spike injected on 120 Vdc

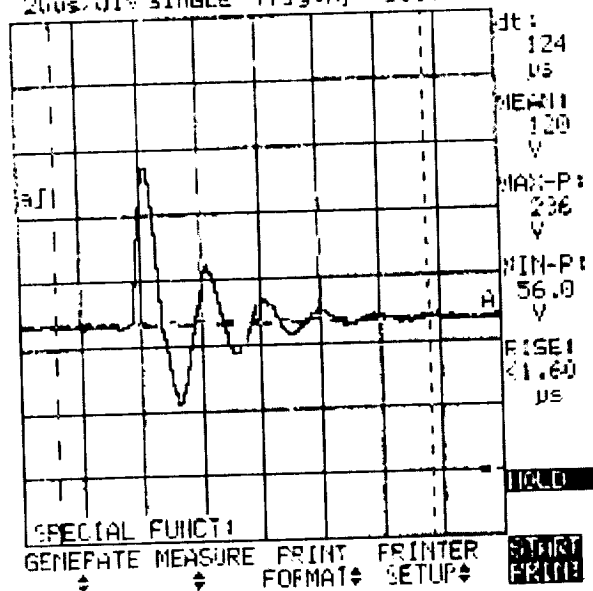
Data 1-7: Spike of Data 1-4 injected into cap F Data 1-8: 500 Volt spike injected on 270 Vdc

Filter F provides the best example of how correctly defining a switching transient provides design relief. Data 1-7 is filter F response to a $50\ \Omega$ spike of total (spike plus line potential) 540 Volts (Data 1-4). The applied spike measured 420 Volts ($540 - 120\text{ V}$) open circuit, and would have measured 210 Volts into $50\ \Omega$. Spike amplitude in Data 1-7 is only 116 Volts ($236\text{ V} - 120\text{ V}$). Filter capacitor succeeds in loading the transient potential sufficiently that no damage is done. Contrast this filter efficiency with what happens when a Model 8282-1 spike is applied to the same filter F, as shown in Figure 3. Data 2-14 shows a 240 spike (from SSP 30237 CS06) developed across $5\ \Omega$. Data 2-15 shows the same spike applied to the capacitor side of filter F.

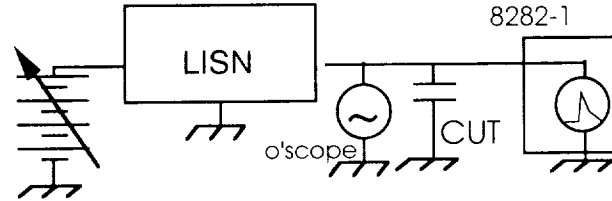
Figure 2: Test set up of CS06-like parallel spike injection

An unloaded source potential of about 700 Volts may also be deduced from this data. The test set up was identical to CS06 parallel injection with two differences. A MIL-STD-462D LISN was used in lieu of the MIL-STD-462 suggested 20 μH coil, and the EUT (capacitor) was connected directly to the Model 8282-1 parallel output banana jacks. Lead lengths were thus minimized. Pictures of test set up may be viewed in Appendix A.

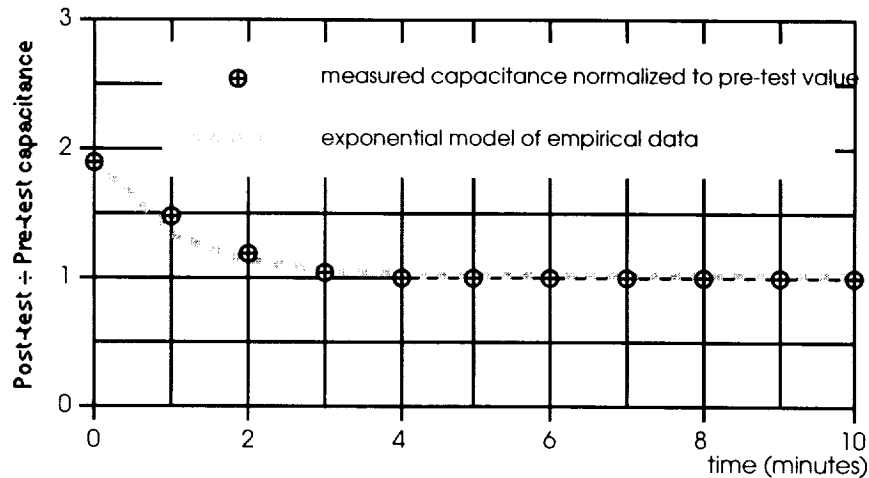
Figure 3: Capacitance as a function of post-test time

Strong correlation between capacitance and predicted temperature as a function of time indicates a very high probability of a causal relationship between electrolyte temperature and capacitance.

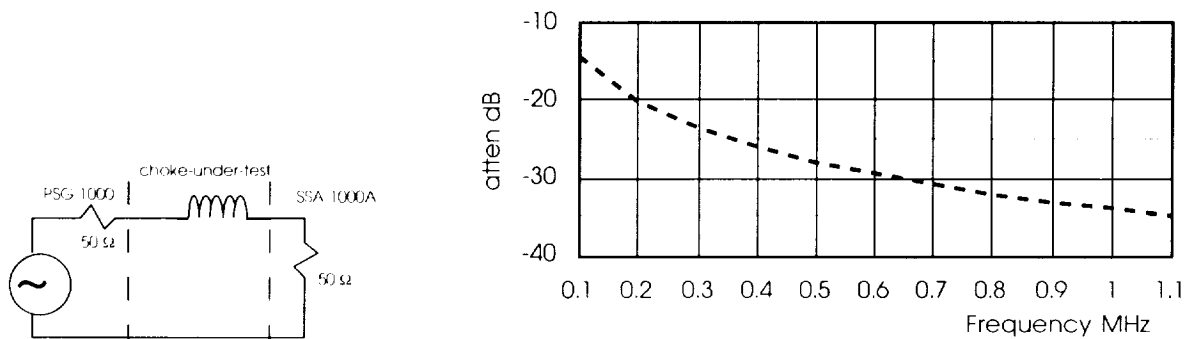
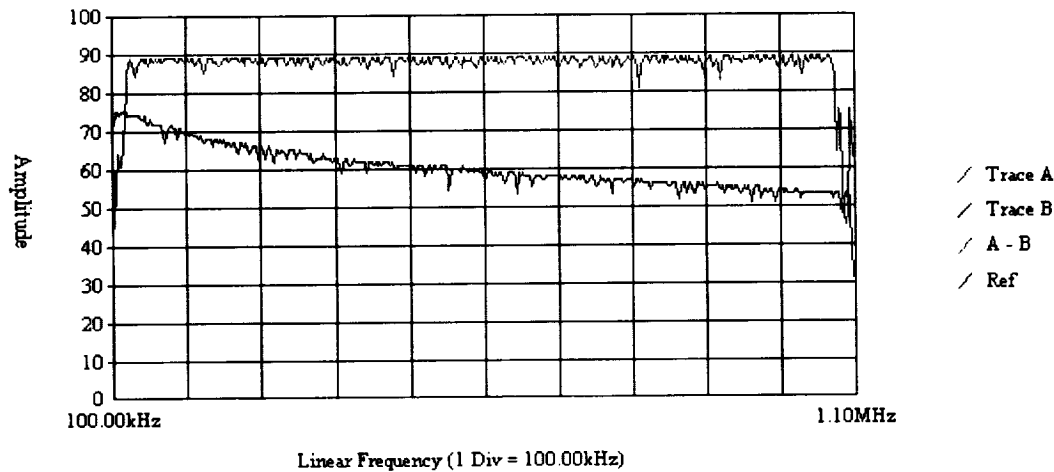
No manufacturer specifies filter series inductance, so this had to be measured. A series insertion loss technique was used. The filter was placed in series between a 50 Ω signal source and a 50 Ω spectrum analyzer. No connection whatsoever was made to the filter case, so the capacitor had no effect on the measurement. A baseline measurement was made without the filter in line, so that insertion loss could be ascertained. The equation which predicts the insertion loss is:

Test set-up schematic and equation is plotted below for $L = 400 \mu\text{H}$, over a 100 to 1100 kHz range. Test data shows excellent agreement with theoretical insertion loss for 400 μH . Test data upper trace A is a baseline measurement without the filter in the test circuit. The lower trace B is due to the insertion of the inductor in series between signal source and receiver.

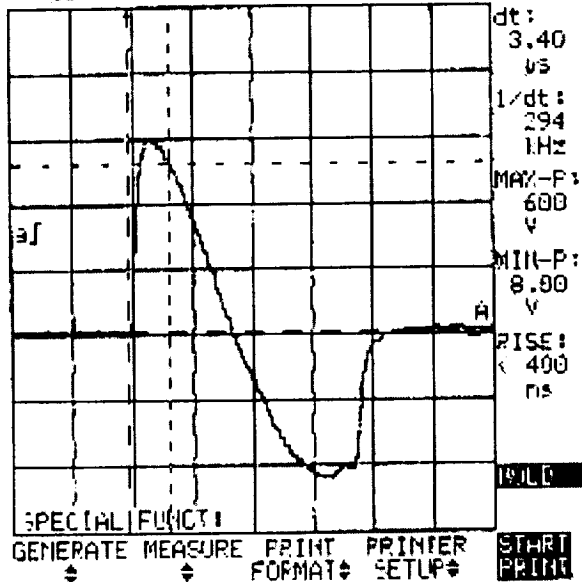
Data 2-1: 600 V spike across 5 Ω

The 600 V, 10 μs spike of Data 2-1 was injected on to capacitors B through E, with no test failures. All tantalum electrolytics got very hot during this test. These tests were run for at least one hour at one pulse per second. The ceramics were run at 2 pps with no noticeable heating. One tantalum electrolytic, capacitor E, read 386 μF immediately at test end (very hot), but 316 μF after returning to ambient temperature. This was not deemed a failure.

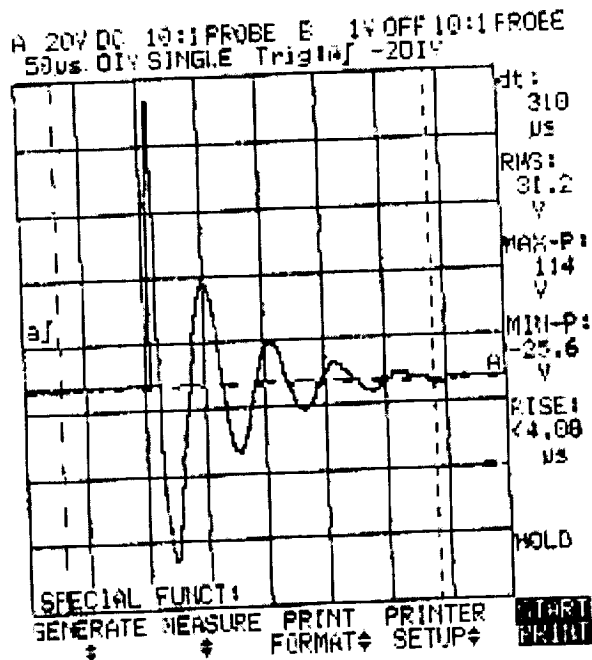
Data 2-3: Data 2-1 generator setting develops this spike across capacitor E

The most important result here is Data 2-3. This is the induced spike across the 300 μF , 30 Vdc rated capacitor (E) biased at 28 Vdc. With absolutely no headroom to spare, this capacitor still did not fail when the 600 Volt spike was injected. Note that about 600 Amps was flowing at the peak of the spike waveform in order to result in an applied spike amplitude of 114 Volts (greater than 700 Volts source potential loaded through 1 Ω source resistance down to approximately 100 V). It is quite reasonable to extrapolate from this result that no properly derated tantalum electrolytic bulk capacitor will be damaged by any low duty cycle CS06 - like spike application.

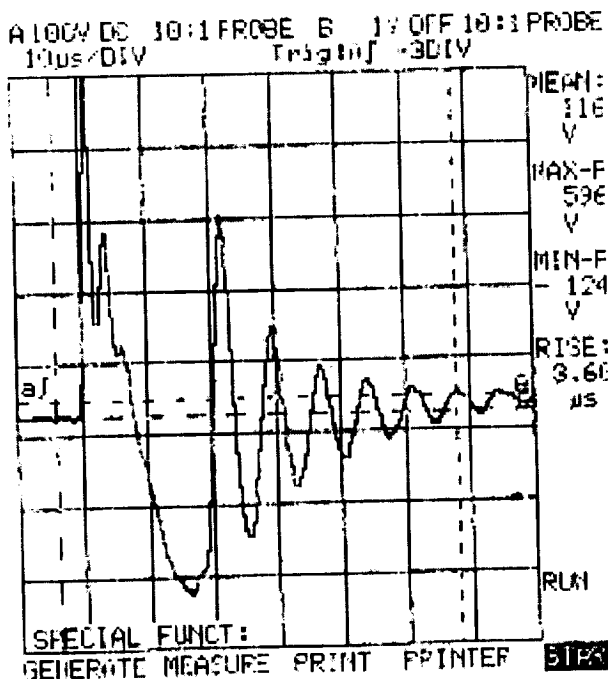
Data 2-15: Filter F response to Data 2-14 spike injected into capacitor side

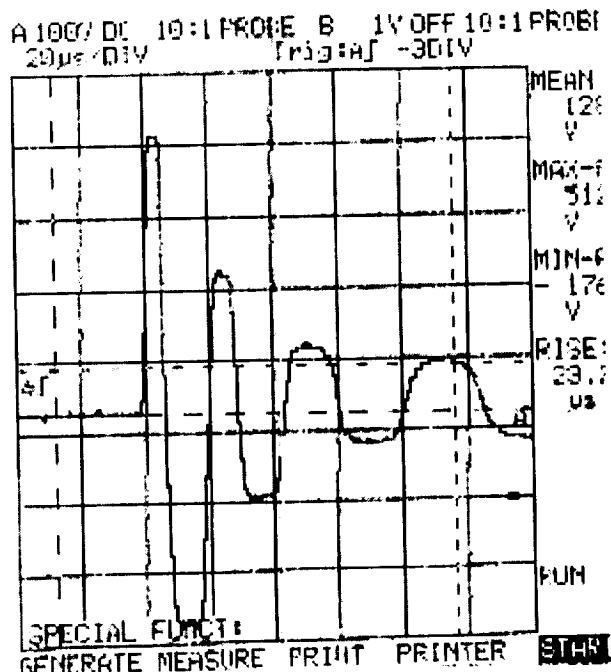
Data 2-16: Filter F response to Data 2-14 spike injected into inductor side (measured across capacitor)

The peak potential has increased from that shown in Data 2-14 because the capacitor is a higher impedance than $5\ \Omega$. If the filter is turned around so that the inductor bears the brunt of the spike, the potential across the capacitor is shown in Data 2-16. Spike potential is reduced from that measured when injected directly into the capacitor, but it still exceeds the potential the Model 8282-1 can deliver into $5\ \Omega$. The inductor is incapable of significantly filtering the spike.

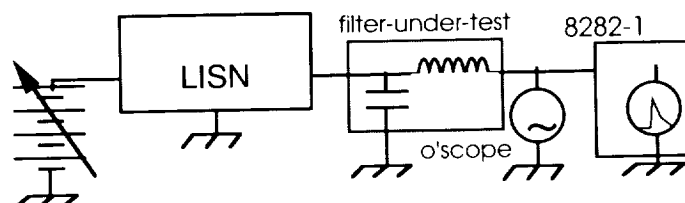
Figure 3: Test set up of CS06-like parallel spike injection for single filter F. (Either cap side or inductor side face the spike source.)

However, the test set-up of Figure 3 harkens back to the days when a MIL-F-15733 type filter was installed in just such a line-to-ground configuration because power current was returned

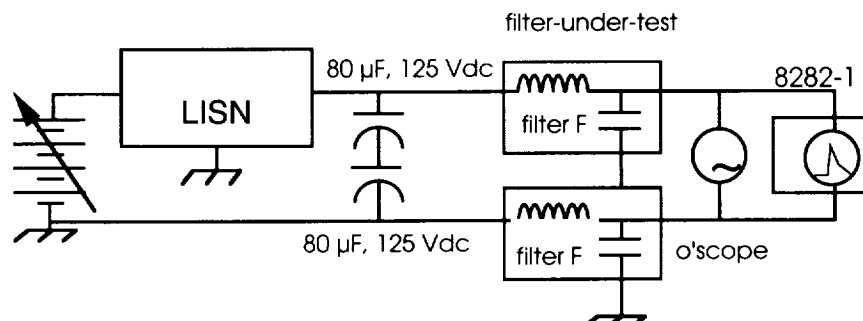
Figure 4: Test set up of CS06-like parallel spike injection for two filters F in modern power bus topology.

In Figure 4, the filters F are paralleled by $40\ \mu\text{F}$ of bulk capacitance. This should help to lower the spike potential across capacitors in filter F, but filter F inductors interfere with that function. Data 2-17 shows a 450 Volt spike calibrated across $5\ \Omega$. This is the potential at which a single application destroyed a stand-alone filter F. Data 2-18 shows the spike potential when the setting resulting in Data 2-17 is applied as in Figure 4. For comparison, Data 2-19 shows spike potential between filters F and the bulk capacitors. Almost the entire spike potential is dropped across filters F. However in this test configuration the 450 Volt spike did not affect the filters F, even applied at a rate of 10 pps for several minutes. When the spike potential was increased to 500 Volts (at a rate of 10 pps) it caused filter F capacitor failure in less than one minute.

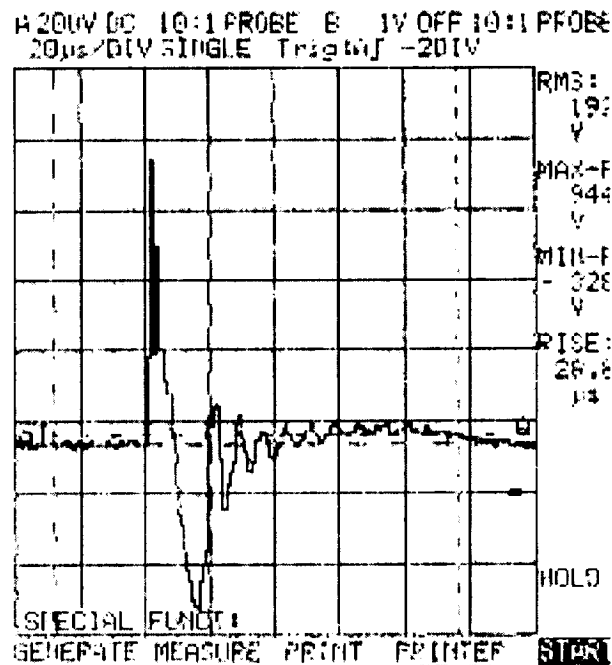
Data 2-18: Data 2-17 generator setting develops this spike across filters F in Fig. 4 configuration

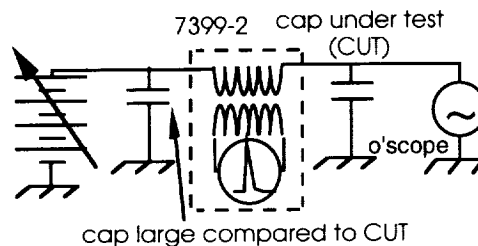
Figure 5: Test set up of CS06-like series spike injection

An unloaded source potential of about 2000 Volts may also be deduced from this data. The test set up was identical to CS06 series injection with only the 7399-2 replacing the Model 8282-1. The capacitor under test was placed in an explosion chamber in case it failed catastrophically. Pictures of test set up may be viewed in Appendix A.

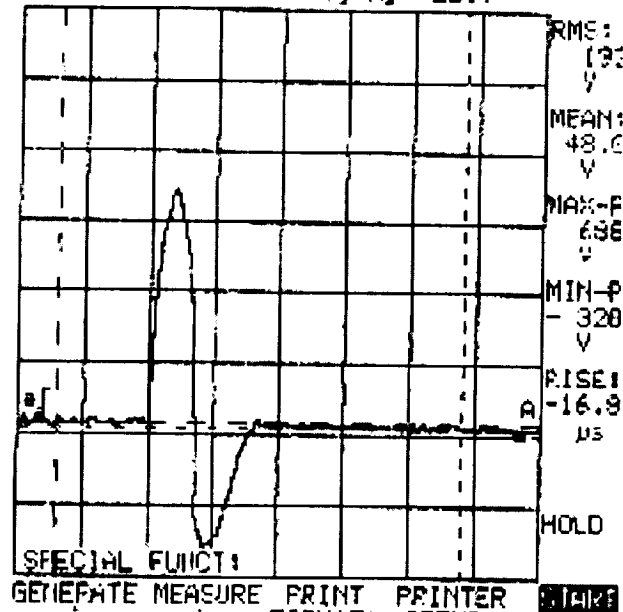
Data 3-5: Data 3-1 generator setting develops this spike across capacitor E, which caused eventual failure

Capacitor E failed at a Solar Model 7399-2 spike source applied potential of 600 Volts for 20 μ s. Amplitude was 1.32 kV into a 0.5 Ω resistor. The spike source impedance was 0.25 Ω . It took almost four hours to fail the capacitor, with spikes applied at a rate of two pulses per minute.

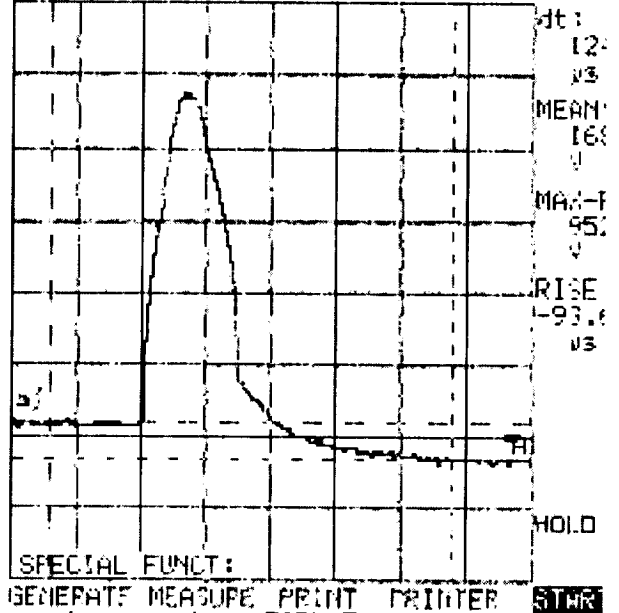
Data 3-15: Data 3-14 generator setting develops this spike across capacitor A.*

* Note that whereas at lower potentials the capacitor A spike potential was roughly half of the potential applied to 0.5 Ω, here the capacitor potential has risen to about 70% of the 0.5 Ω potential. This was indicative of the onset of capacitor failure. After application of this spike, the pre-test nominal capacitance of 140 μF was reduced to 1 μF.

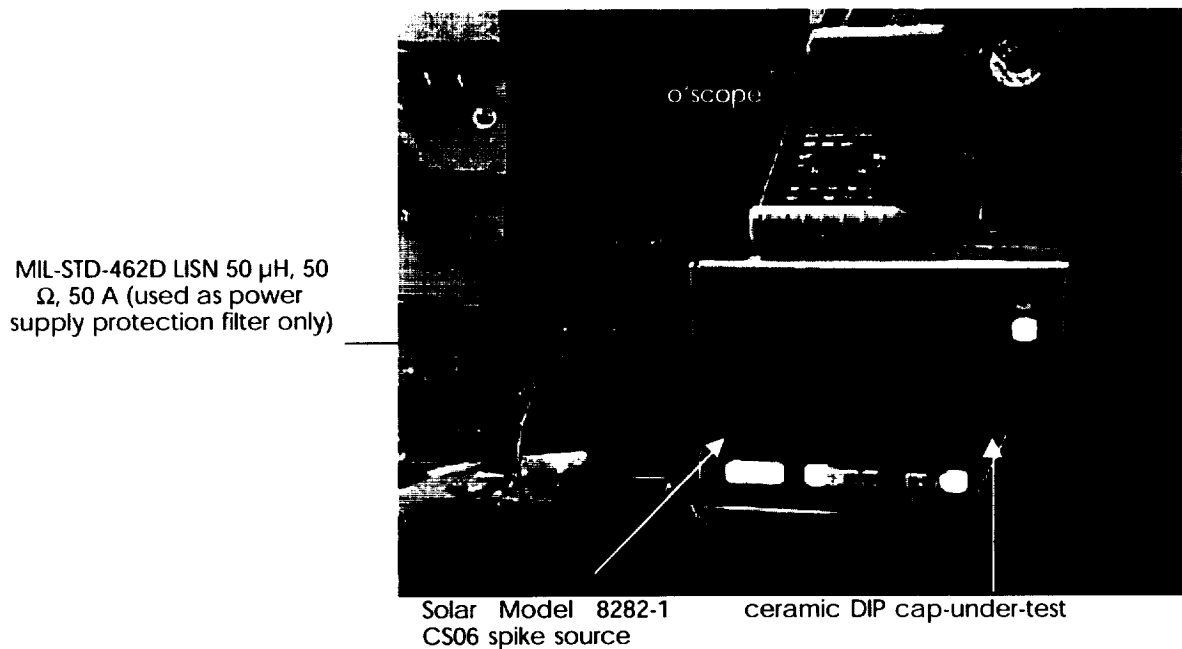
Picture 3: CS06 parallel injection test set up. The LISN here is a filter protecting the power supply output from the CS06 spike. Note that capacitor under test is connected directly to Model 8282-1 parallel output jacks to minimize lead impedance. Figure 2 (from section 3.2.2) below is a schematic of above test set up:

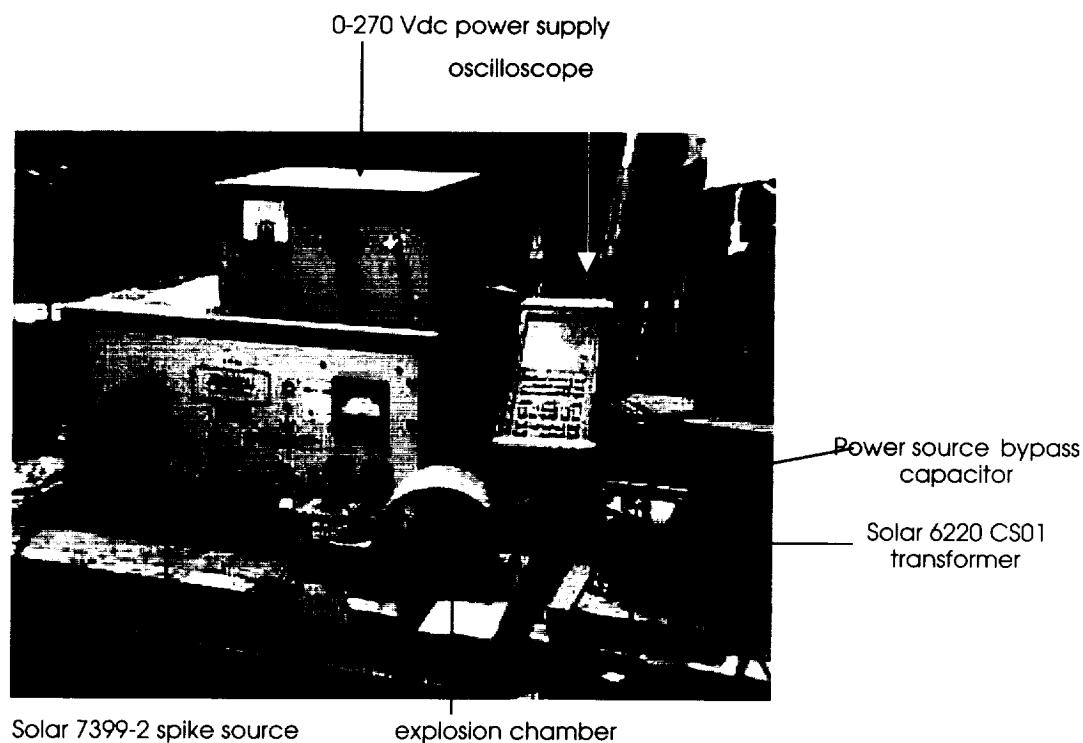
Picture 5: MIL-STD-1399 series injection test set up. Explosion chamber holds capacitor under test. Solar transformer is extra protection for power supply, recommended by Solar 7399-2 instruction manual. For clarity, it is not shown in schematic below (Figure 5 of section 3.2.3):

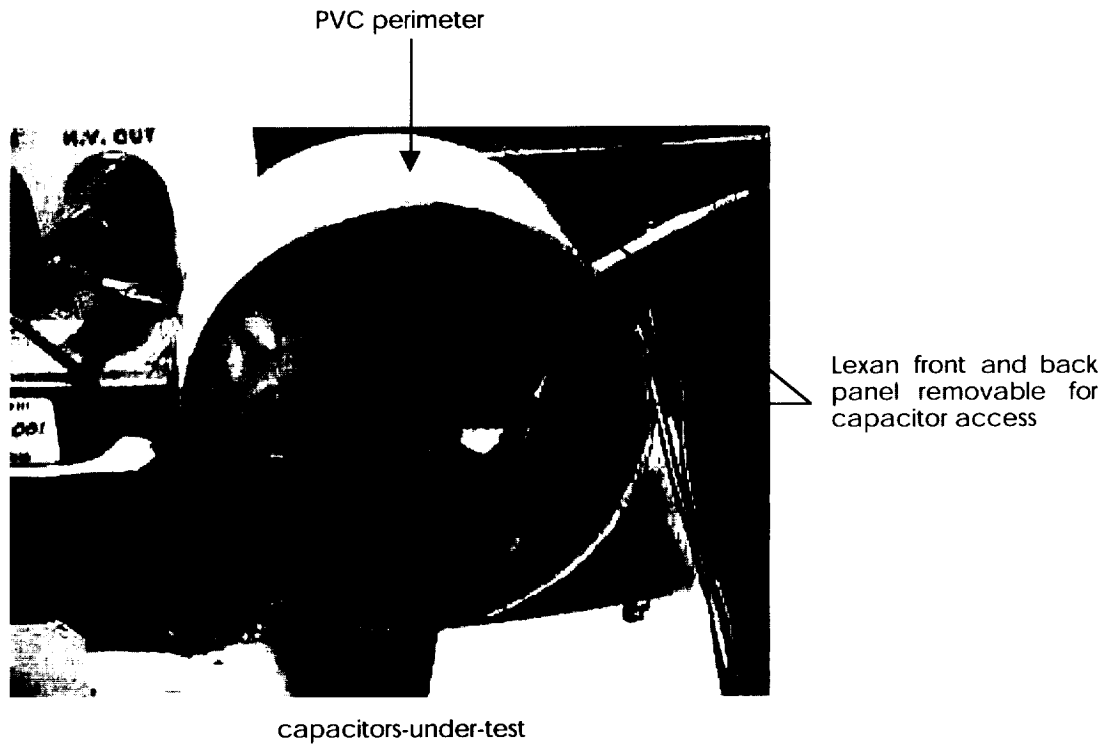
Picture 6: Close up of explosion chamber with capacitor B (two series 125 Vdc rated capacitors ganged for Space Station power bus derating) installed.

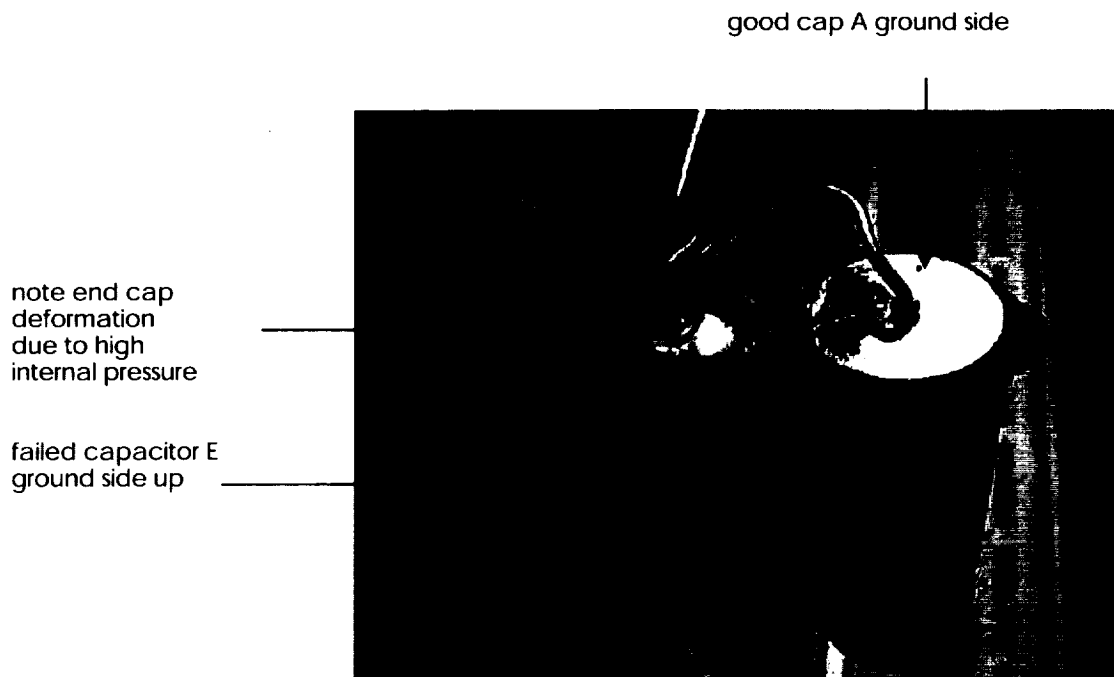
Picture 7: End view comparison of failed capacitor E with good capacitor A (same package). Capacitor E is seen to have undergone explosive compression, which, however, was contained by its case. Capacitor failed open; its failure would not have directly caused other circuit malfunction, except by its failure to perform its original function.
